KIRK STREET AGENTS' HOUSE

Lowell National Historical Park

Historic Structure Report

Written 1990 - Published 1997

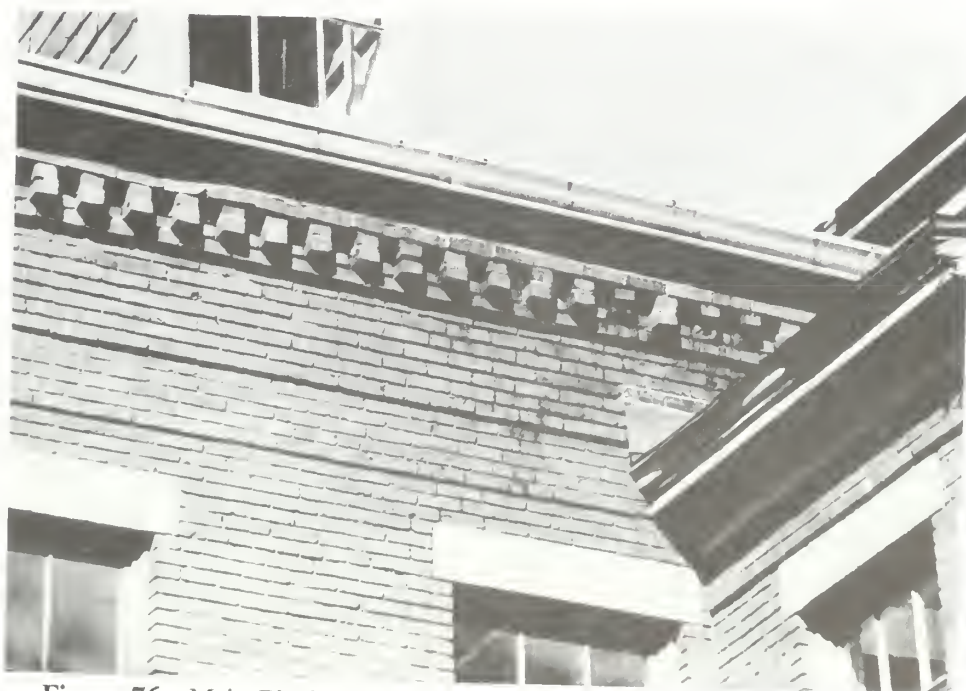
Figure 76. Main Block, East Elevation: Cornice and Eaves at Stair Tower.

South (Rear-Yard) Elevation. As on the north side of the roof, a remnant of an early wood gutter can be seen under the extant roofing (fig. 76). It, too, was part of a gutter system that served the former roof over the stair tower and the north unit's ell.
